PROBABLE ATOMIC ENERGY COMPLEX UNDER CONSTRUCTION
NEAR CHIH-CHIN-HSIA, CHINA,

NPIC/R-740/64

### **SUMMARY**

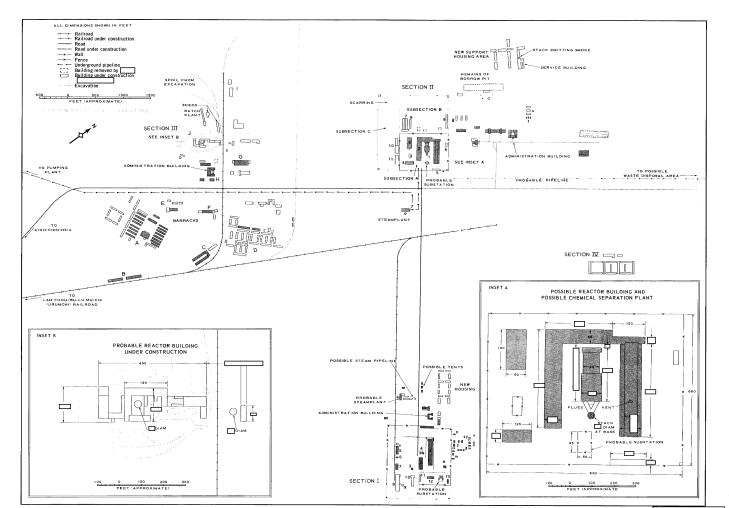
FIGURE 3. LAYOUT OF PRODUCTION AREA. Insets show small possible reactor building, possible chemical separation plant, and large probable reactor building under construction.

The secured area of Section II, which originally measured 890 by 680 feet, has been expanded northwest and southwest to measure approximately 1,385 by 1,290 feet (Figure 3). The area is now surrounded by a wall with a guard tower in each corner. Apparently the secured area is divided by fences into Subsections A, B, and C, of which A is the area previously reported.

Subsection A contains two major structures (items 1 and 2, Table 2 and Figure 3) which were reported earlier as one building. Building 1 (see inset A, Figure 3) has the appearance of a small reactor building, measuring approxiwith a T-shaped extension, possibly for slug-removal, to the northwest. A stack, estimated to be 340 feet high and in diameter at the base, is

adjacent to the building on the southeast side, and is con-
	nected to the possible reactor building by two flues which
	form a V. No smoke or vapor has been observed being
5X1	emitted by the stack on the recent photography.
	Building 2 (see inset A, Figure 3) has an irregular U-shaped
	plan, and is possibly a chemical separation plant. The north-
5X1	east leg measures approximately and has a

Building 2 (see inset A, Figure 3) has an irregular U-shaped plan, and is possibly a chemical separation plant. The north25X1 east leg measures approximately and has a central portion about and approximately twice the height of the lower portion. A probable vent protrudes from the roof of the elevated portion. This northeastern leg has a head section about which suggests the previously reported T configuration. 1/ The head sec-

Subsection B, which measures 890 by 695 feet, has been developed since the subsection contained three buildings (items 7-9, Figure 3). The most important is a T-shaped fabrication-type structure (item 7) with a monitor on its stem. The bar portion appears to be as high or higher than the monitor. In addition to the

Subsection C measures 1,385 by 400 feet and contains an irregular-shaped structure (item 10, Table 2 and Figure 3) which may still be under construction and a configuration (item 11) which may be another building under construction or framing for a traveling crane. Scarring in the northwest corner may indicate another building under construction.

A new probable pipeline can be traced from the vicinity of the possible reactor building in a northeasterly direction to a newly identified possible waste disposal area, 2.8 nm away (Figures 2 and 3). Mounds of earth in this area may indicate burial of waste material.

Section III has undergone considerable expansion between and construction activity continues in several of its subsections. A probable large reactor building is under construction in Subsection J on the site of a previously observed excavation. 1/ Because of the continuing construction, no security wall has yet been erected around the section (Figure 3).

the completed work. Approximate measurements are given in inset B, Figure 3. No concrete work had reached ground level by A circular configuration about in diameter in one of the inner rooms may be the future foundation support for the reactor.

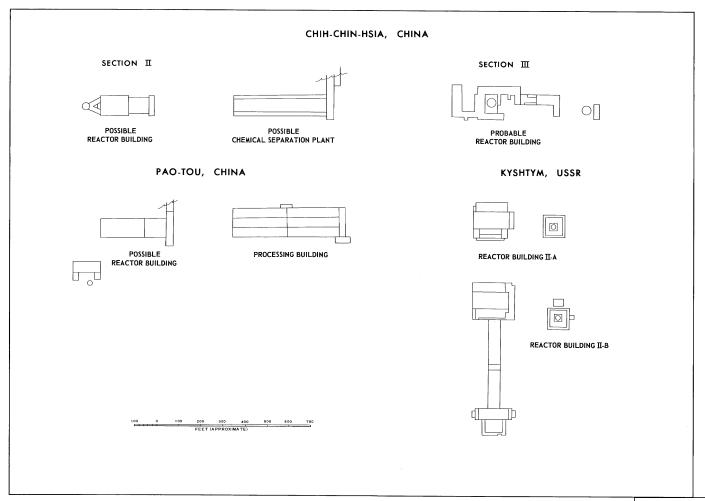
FIGURE 4. COMPARATIVE PLANS OF BUILDINGS AT CHIH-CHIN-HSIA AND PAO-TOU, CHINA, AND KYSHTYM, USSR.

Section II of the Production Area, with its possible reactor building and possible chemical separation plant, may be compared with other atomic energy installations in Communist China. 3/4 The high-bay portion of the reactor building in Section C of the Peiping Institute of Atomic Energy 3/ measures the high-bay portion of the possible reactor building at Chih-chin-hsia measures The overall dimensions of the two structures are (Peiping) and (Chih-chinhsia). The high-bay portion of the possible reactor building at the Pao-tou Possible Plutonium Production Facility 4/ is larger than that of the possible reactor building at Chihchin-hsia: the high bay measures overall dimensions of the building are However, similarities exist between the processing buildand the ing at Pao-tou, which measures possible chemical separation plant at Chih-chin-hsia, which (Figure 4). measures The configuration of the completed construction of the

large probable reactor building in Section III of the Production Area at Chih-chin-hsia suggests a similarity to some of the reactor buildings at the Kyshtym Atomic Energy Complex in the USSR (Figure 4). 5/6/
